# *Sawkill Creek*

## *Stream Corridor Assessment Report*

*Ulster County, NY*

*May 2007*

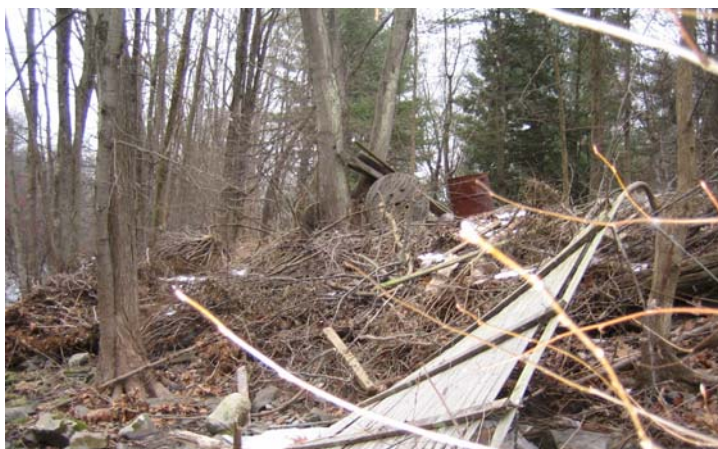
Dumped waste of appreciable quantity was observed and recorded at three locations, including yard debris, general trash, and rubbish. Materials were located at River Station 65+90, 731+70 and 736+50.

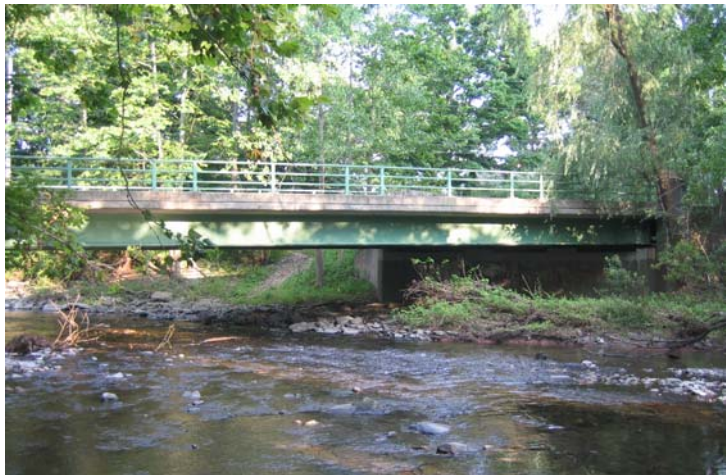
On numerous occasions, the county-owned and maintained bridge on John Joy Road has been inundated by storm flow and debris. This has required emergency response by the Town of Woodstock Highway Department to relieve debris blockages. Floodwater has damaged John Joy Road on several occasions, which has resulted in costly repairs. Streambank erosion and large accumulations of sediment and debris have been inventoried in the reach upstream of the bridge, which also suggests a backwater condition at the bridge.

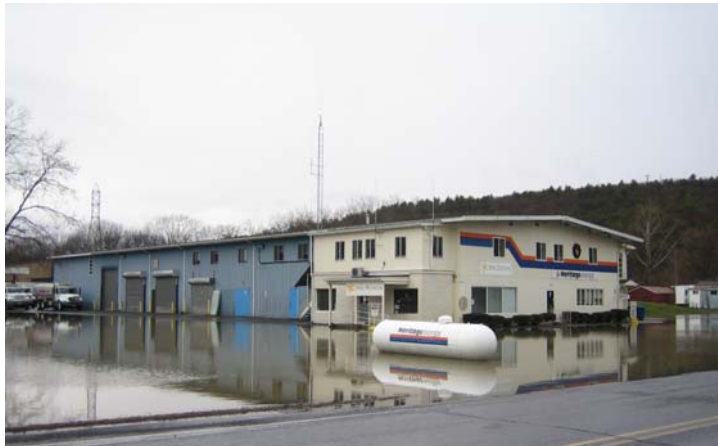
The Floodplain Coordinator informed the group that on several occasions the parking lot of Heritage Energy, a local heating oil business, has been flooded. Although this typically occurs only during large storm events, it was not believed that the actual building or ancillary structures were affected. It was added that several berms located along the floodplain had been recently removed by

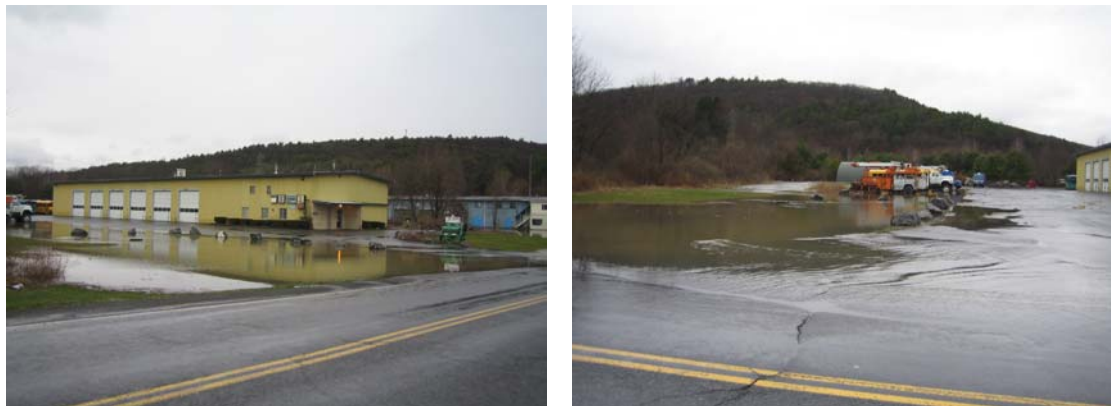
Flooding of the Heritage Energy and Eagle Diesel Power parking lots were observed on April 16, 2007 following a heavy rain event. During this event the Sawkill Creek did not crest the top of the bank, or result in flooding of the area. Flood water from the small unnamed tributary which flows east along the property owned by Eagle Diesel Power, was observed overtopping its banks and inundating the area west of Sawkill Road. This condition may aggravate and increase flooding of the area during periods where inundation occurs as the result of the Sawkill Creek flooding.
