Town of Woodstock  
Natural Resources Inventory

## 7. Soils

### Soil Erosion Hazard Rating

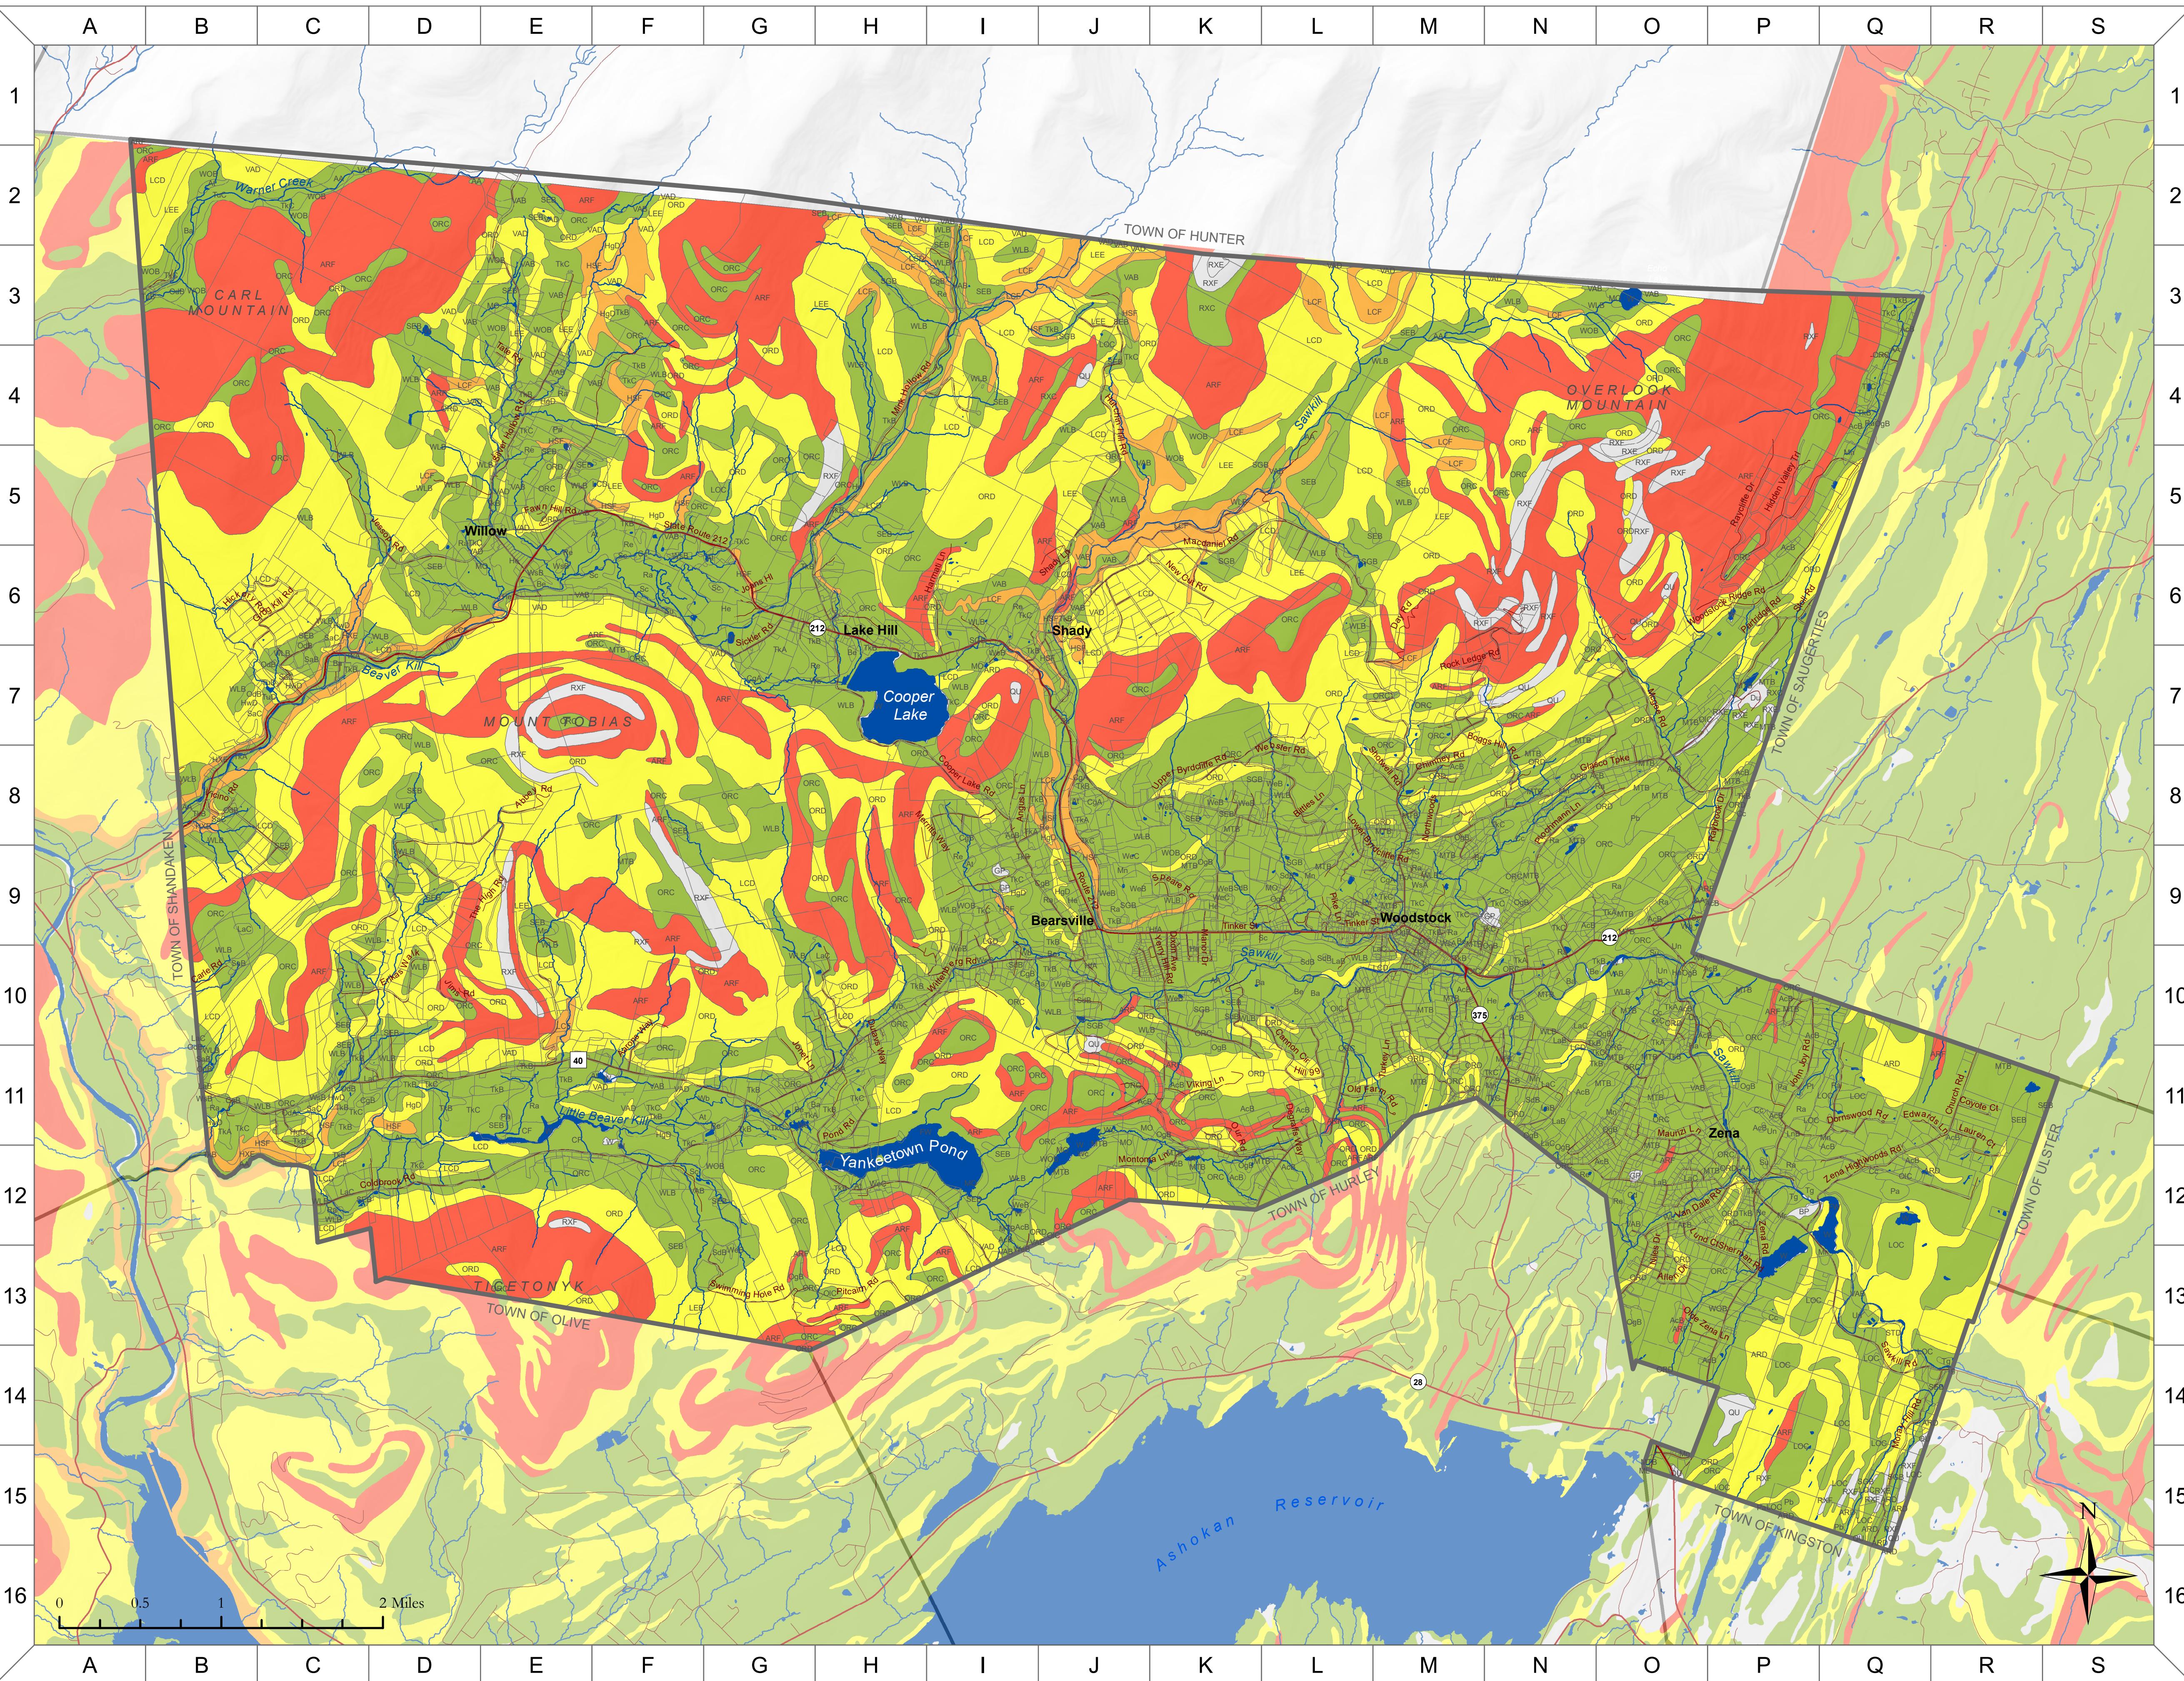
- Very severe
- Severe
- Moderate
- Slight
- Not rated

Definition: The hazard of soil loss from off-road and off-trail areas, where 50 to 75 percent of the surface has been exposed by logging, grazing, mining, or other kinds of disturbance.
