# *Sawkill Creek*

## *Stream Corridor Assessment Report*

*Ulster County, NY*

*May 2007*

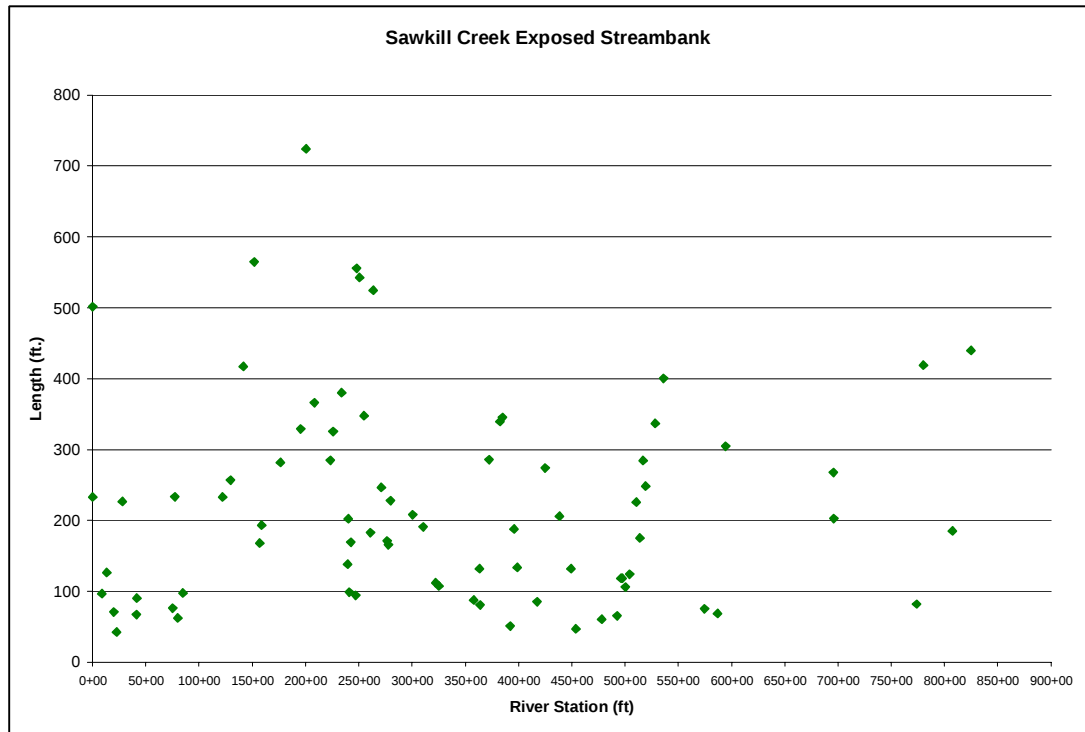
Figure 1. Length of exposed streambank measured along Sawkill Creek.

The total length of eroded bank was 17,430 feet (3.3 miles) over the 83,420-foot (15.6 mile) long assessment of the Sawkill Creek, representing approximately 20.9% of the total stream channel length or 10.5% of the total streambank length. The average length of eroded stream banks was 220 feet, with an average height of 10.6 feet.

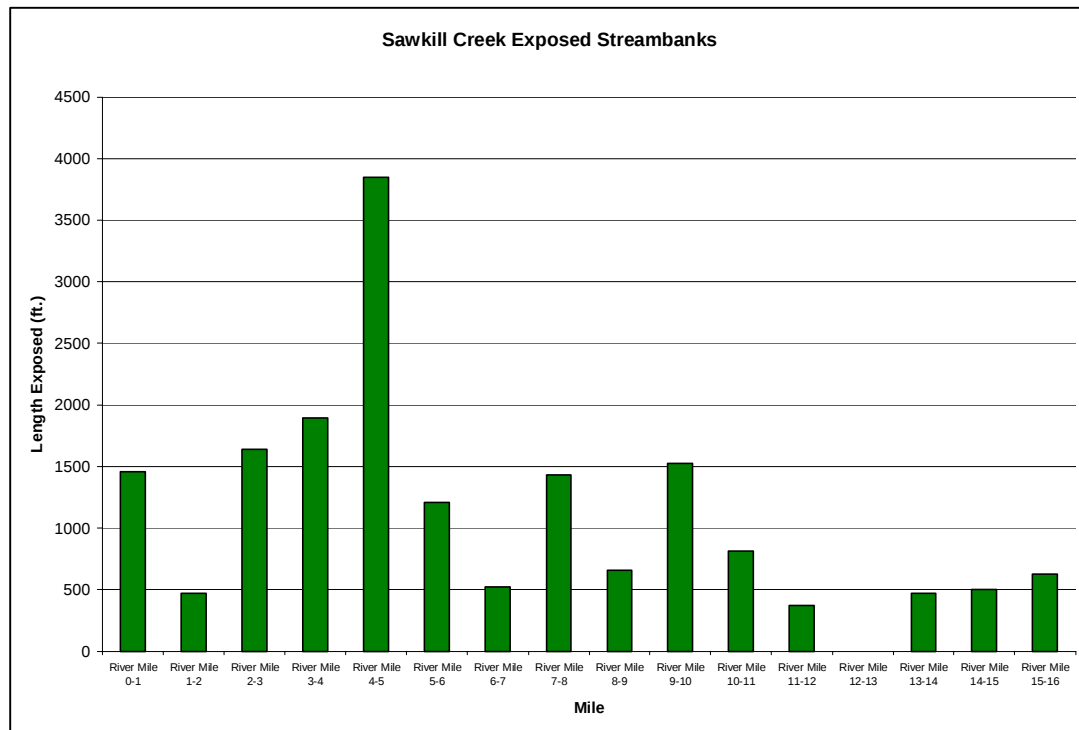
**Figure 4. Length of exposed streambank on the Sawkill Creek expressed by River Mile.**

Streambank erosion data was further delineated by river mile, as displayed in Figures 4 and 5. The largest total length of eroded bank occurs in River Mile 4-5, while the largest exposed bank area is located in River Mile 0-1.

In order to initially prioritize reaches for future management and planning, stream reaches were sorted by total exposed area and total length, Table 2. River Mile 4-5 is ranked highest of the reaches with the longest length of eroded streambank, and third in eroded bank area. In theory, effective streambank stabilization and/or restoration within River Mile 4-5 could reduce the eroded length of streambank over the entire corridor by nearly 22% and reduce the exposed area of streambank by 13%.

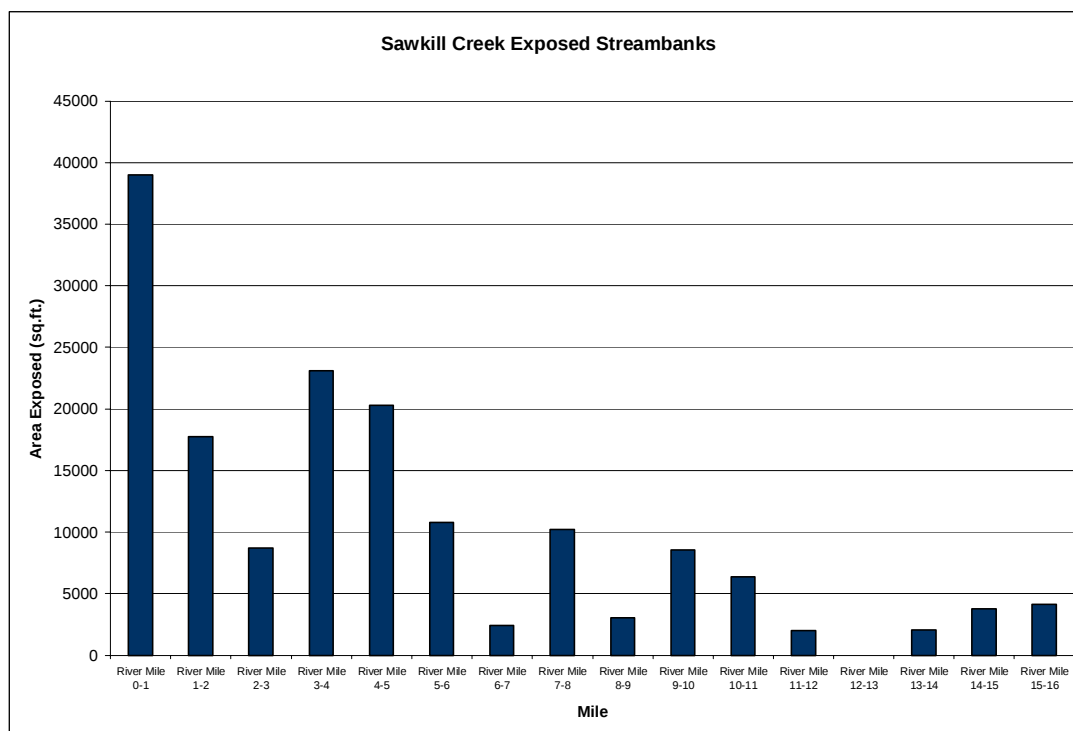
**Figure 5. Area of exposed streambank on the Sawkill Creek expressed by River Mile.**

Similarly, adjoining River Mile 3-4 ranked second in both eroded area and length. Nearly 1/3 of the inventoried eroded streambanks by length are located within this two-mile stretch.

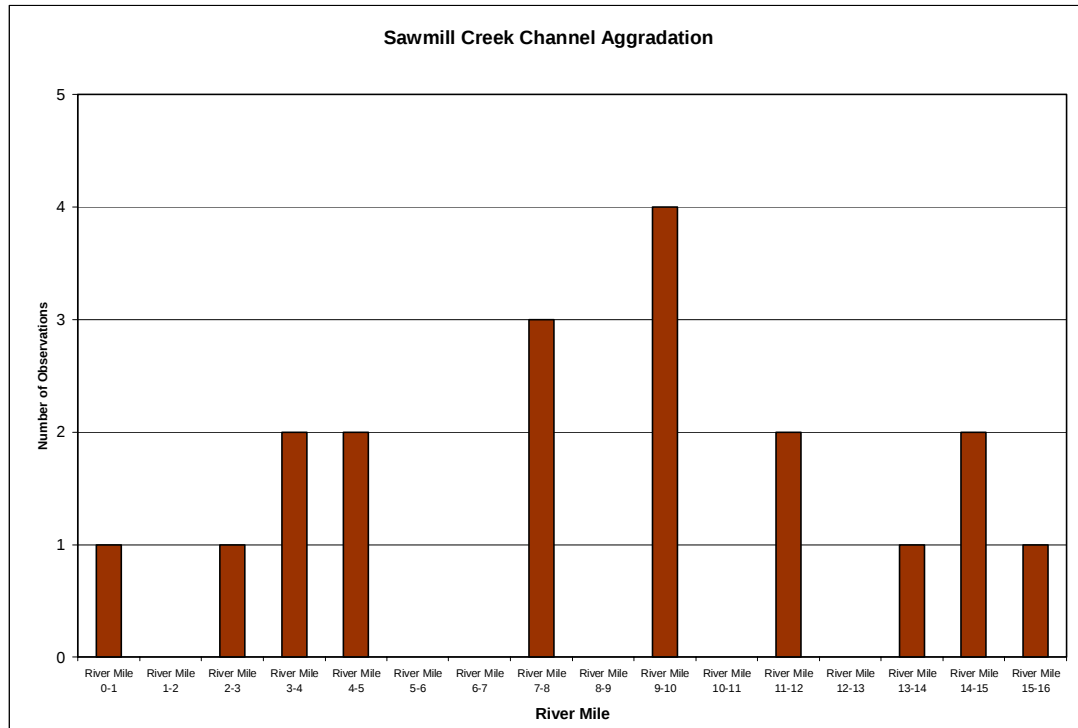
**Figure 6. Instances of channel aggradation displayed by River Mile.**

Signs of sedimentation were observed in nineteen (19) reaches of the Sawkill, typically in the form of sediment deposition or an aggrading channel bed. Figure 6 shows the instances of aggradation stratified by River Mile. The greatest number of observations was recorded in River Mile 9-10. River Mile 9-10 also contains excessive streambank erosion in the lower portion of the reach near John Joy Road Bridge. This area is discussed in detail in the Site Recommendations section of this report.

In stream systems with excessive erosion and sedimentation, reduction of sediment can only be effectively accomplished by addressing the sources of sediment. This is typically

accomplished by promoting the reestablishment of vegetation on the eroding surfaces, changing land use practices, bank stabilization, seeding, planting, or a combination of these. Public acceptance and application of a set of agreed-upon best management practices may greatly encourage natural stream recovery over the long term on moderately disturbed sites, while more intensive stabilization/restoration may be necessary for more severely disturbed areas.

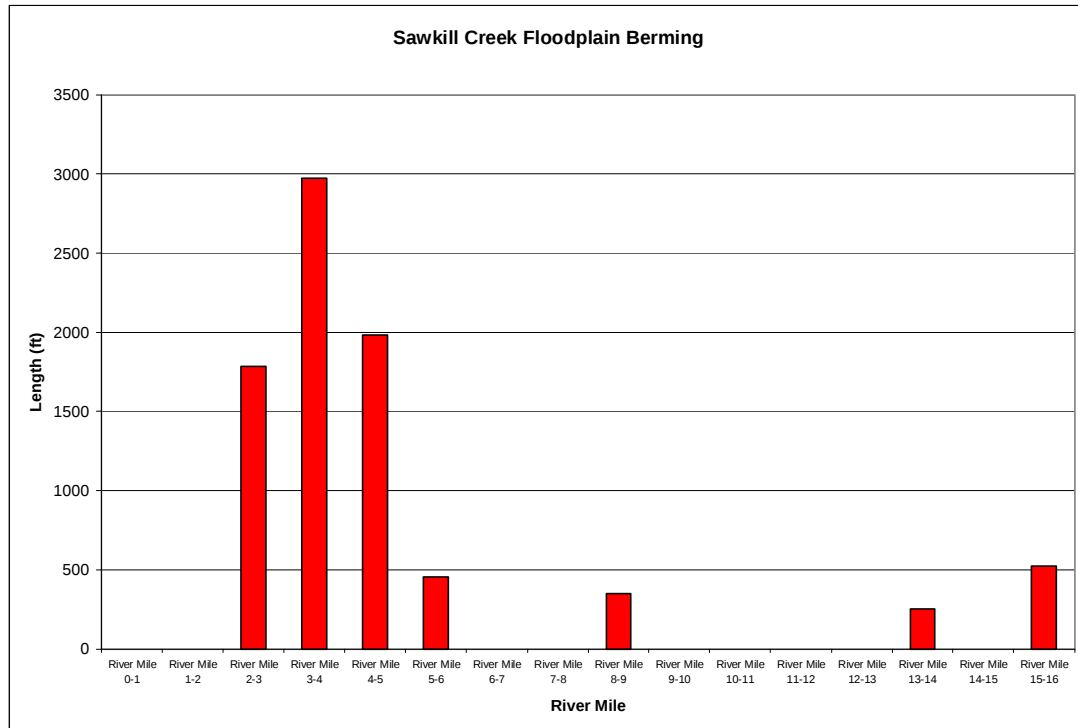
**Figure 7. Length of berms measured along the Sawkill Creek per River Mile.**

Although specific locations prone to flooding and flood damage were not identified as part of this inventory, the location and length of berms was recorded. There were 24 observations of floodplain berming, totaling 8,320 feet in length (Figure 7). Extensive floodplain berming was inventoried in the heavily populated areas of Woodstock, identified as River Mile 3-6. Again, this segment contains the highest percentages of eroded streambank.

The majority of the berms appeared to be constructed from gravel and cobble sediment, presumably side cast material resulting from past channel excavation. The berming observed most likely provides some limited protection from flooding during low to moderate flood events, but since the general construction was formed of stream channel sediment it is likely that it can be easily eroded during large flow events.

Most of the berms inventoried were discontinuous in length and varied in overall height. Variations in the elevations along the majority of the berms inventoried may allow floodwater to easily breach certain areas. Discontinuity may create abnormal divergence and convergence of floodwater and result in unpredictable floodplain deposition and scour. Additionally, the discontinuity may allow floodwater to flow behind the berms and prevent floodwater and ancillary drainage from flowing back into the stream channel.

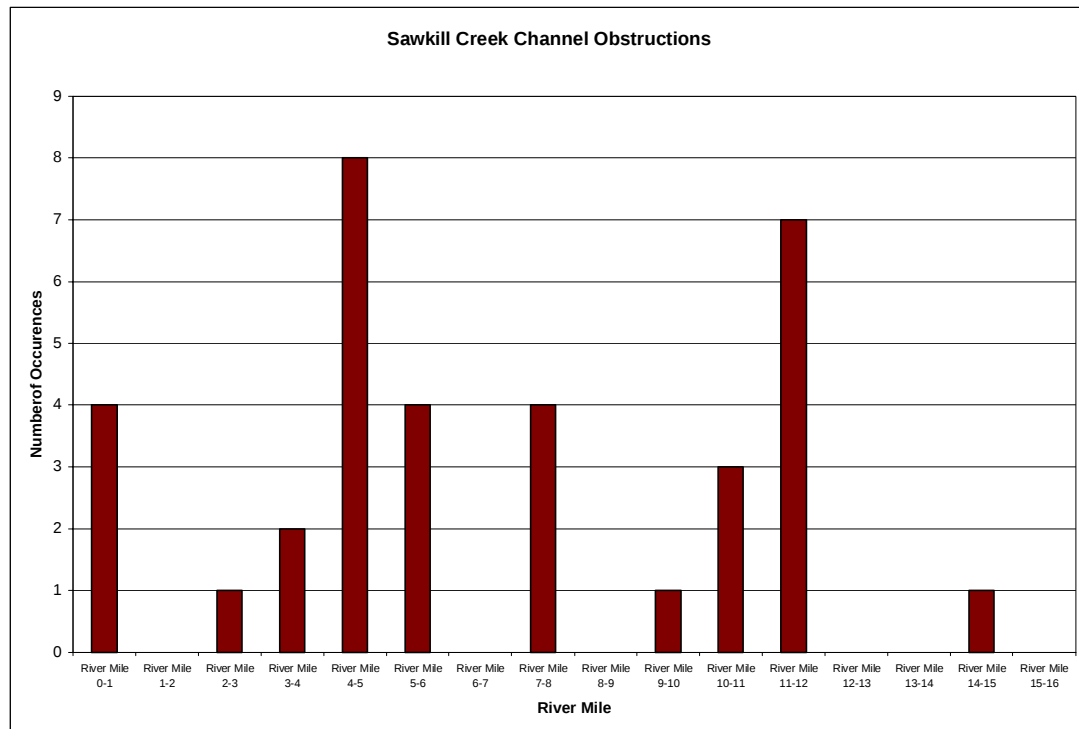
**Figure 8. Instances of debris accumulation and channel obstructions inventoried along Sawkill Creek.**

The inventories of the Sawkill identified thirty-five (35) debris jams, consisting of downed trees and plant materials, some including items such as tires and stone. Figure 8 displays the number of occurrences of debris within the delineated River Miles.

The largest and most extensive quantity of material was located in River Mile 4-5. This reach also had the greatest length in streambank erosion. The position of the reach within the valley and the existing channel morphology naturally promotes deposition of materials. A dramatic decrease in stream and valley slope was observed through the area in relation to upstream adjoining reaches. These result in a reduction in velocity and stream power and a subsequent reduction in the ability to transport both sediment and debris.

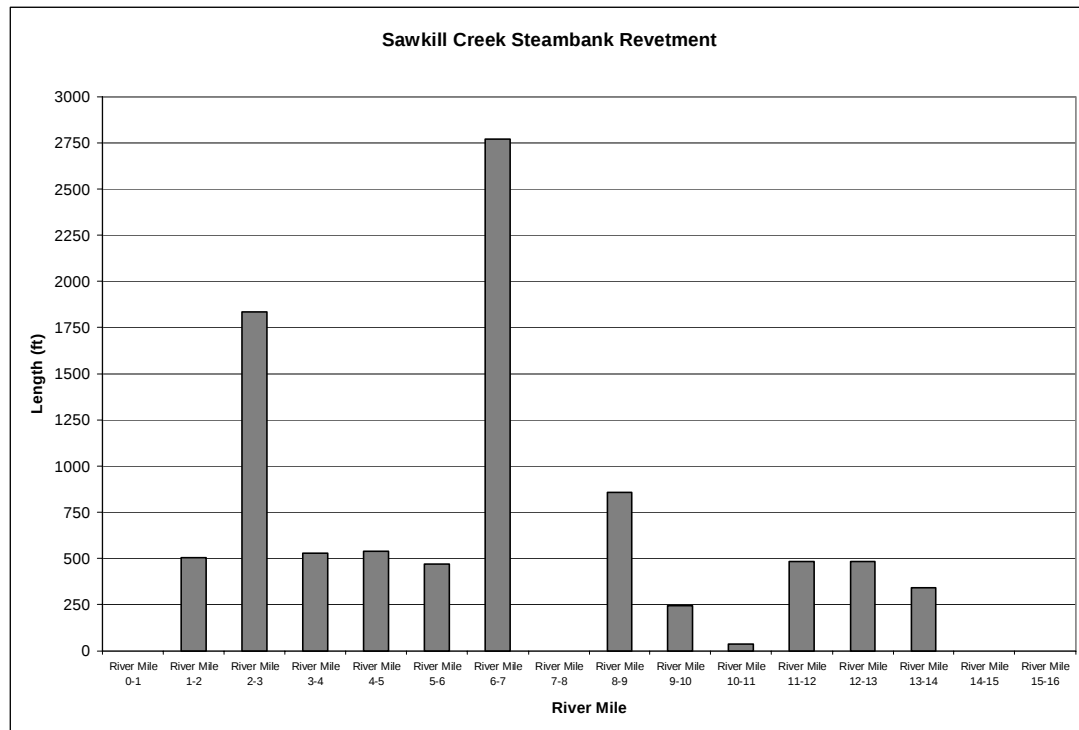
**Figure 9. Streambank revetment inventoried along the Sawkill Creek by River Mile.**

Several types of streambank protection measures have been employed throughout the Sawkill. These include riprap, retaining walls and log cribbing. Figure 9 displays the length of streambank revetment by River Mile.

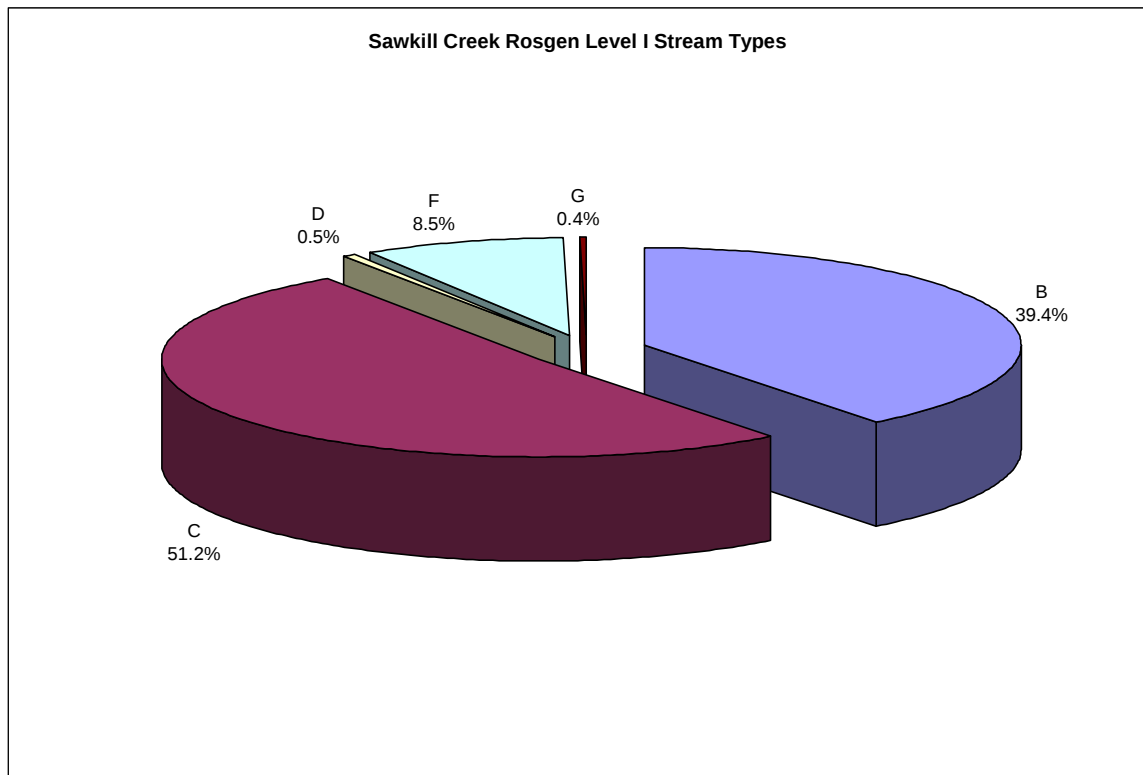
Figure 10. Rosgen Level I Stream Type Distribution for the Sawkill Creek.

Rosgen Level I stream types along the Sawkill were consistent with the landform and slope ranges inventoried. Five stream types were inventoried, including B, C, D, F and G. Figure 10 displays the distribution of stream types.

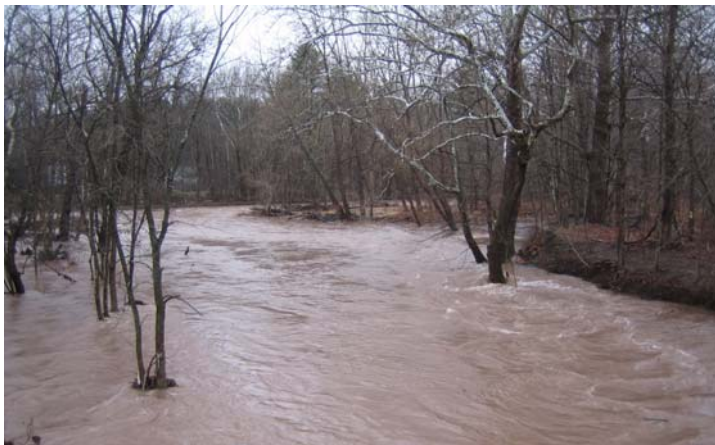
On numerous occasions, the county-owned and maintained bridge on John Joy Road has been inundated by storm flow and debris. This has required emergency response by the Town of Woodstock Highway Department to relieve debris blockages. Floodwater has damaged John Joy Road on several occasions, which has resulted in costly repairs. Streambank erosion and large accumulations of sediment and debris have been inventoried in the reach upstream of the bridge, which also suggests a backwater condition at the bridge.

In addition to the damage and maintenance, the flooding forces the closure of John Joy Road. This requires emergency vehicles and residents to take an approximate 6-mile detour around the flooded site. Department staff confirmed that the road is typically closed once a year due to flooding of this nature, which creates an elevated risk to public safety.

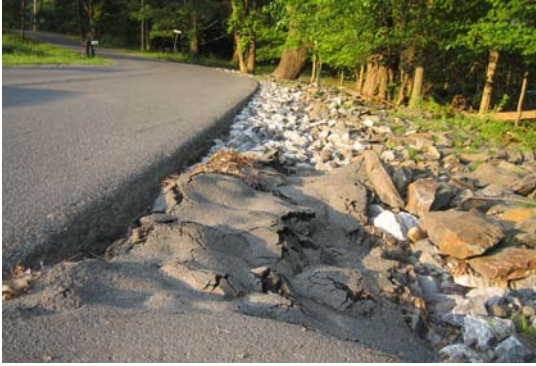
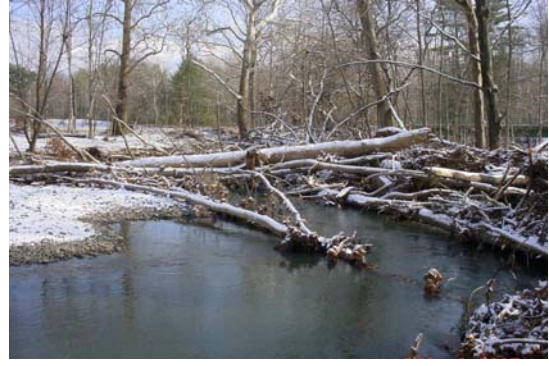
Recently the Town of Woodstock Highway Department was in the process of obtaining regulatory approval to remove a large debris blockage in the stream channel, located approximately 200 feet upstream of the bridge. This plan was being initiated to reduce expected flooding of the roadway and mitigate the potential for the debris to become lodged in the bridge opening. As part of the plan, the department planned to excavate portions of a large depositional feature that was created in the area by the debris accumulation. Before the highway department was able to take action, a flood event occurred, causing water to flow around the bridge structure (to the north) and over John Joy Road. During the flood event, several large trees and their roots blocked the upstream bridge opening and required emergency removal by the Department. Significant repair was necessary along the road as a result of the damage.

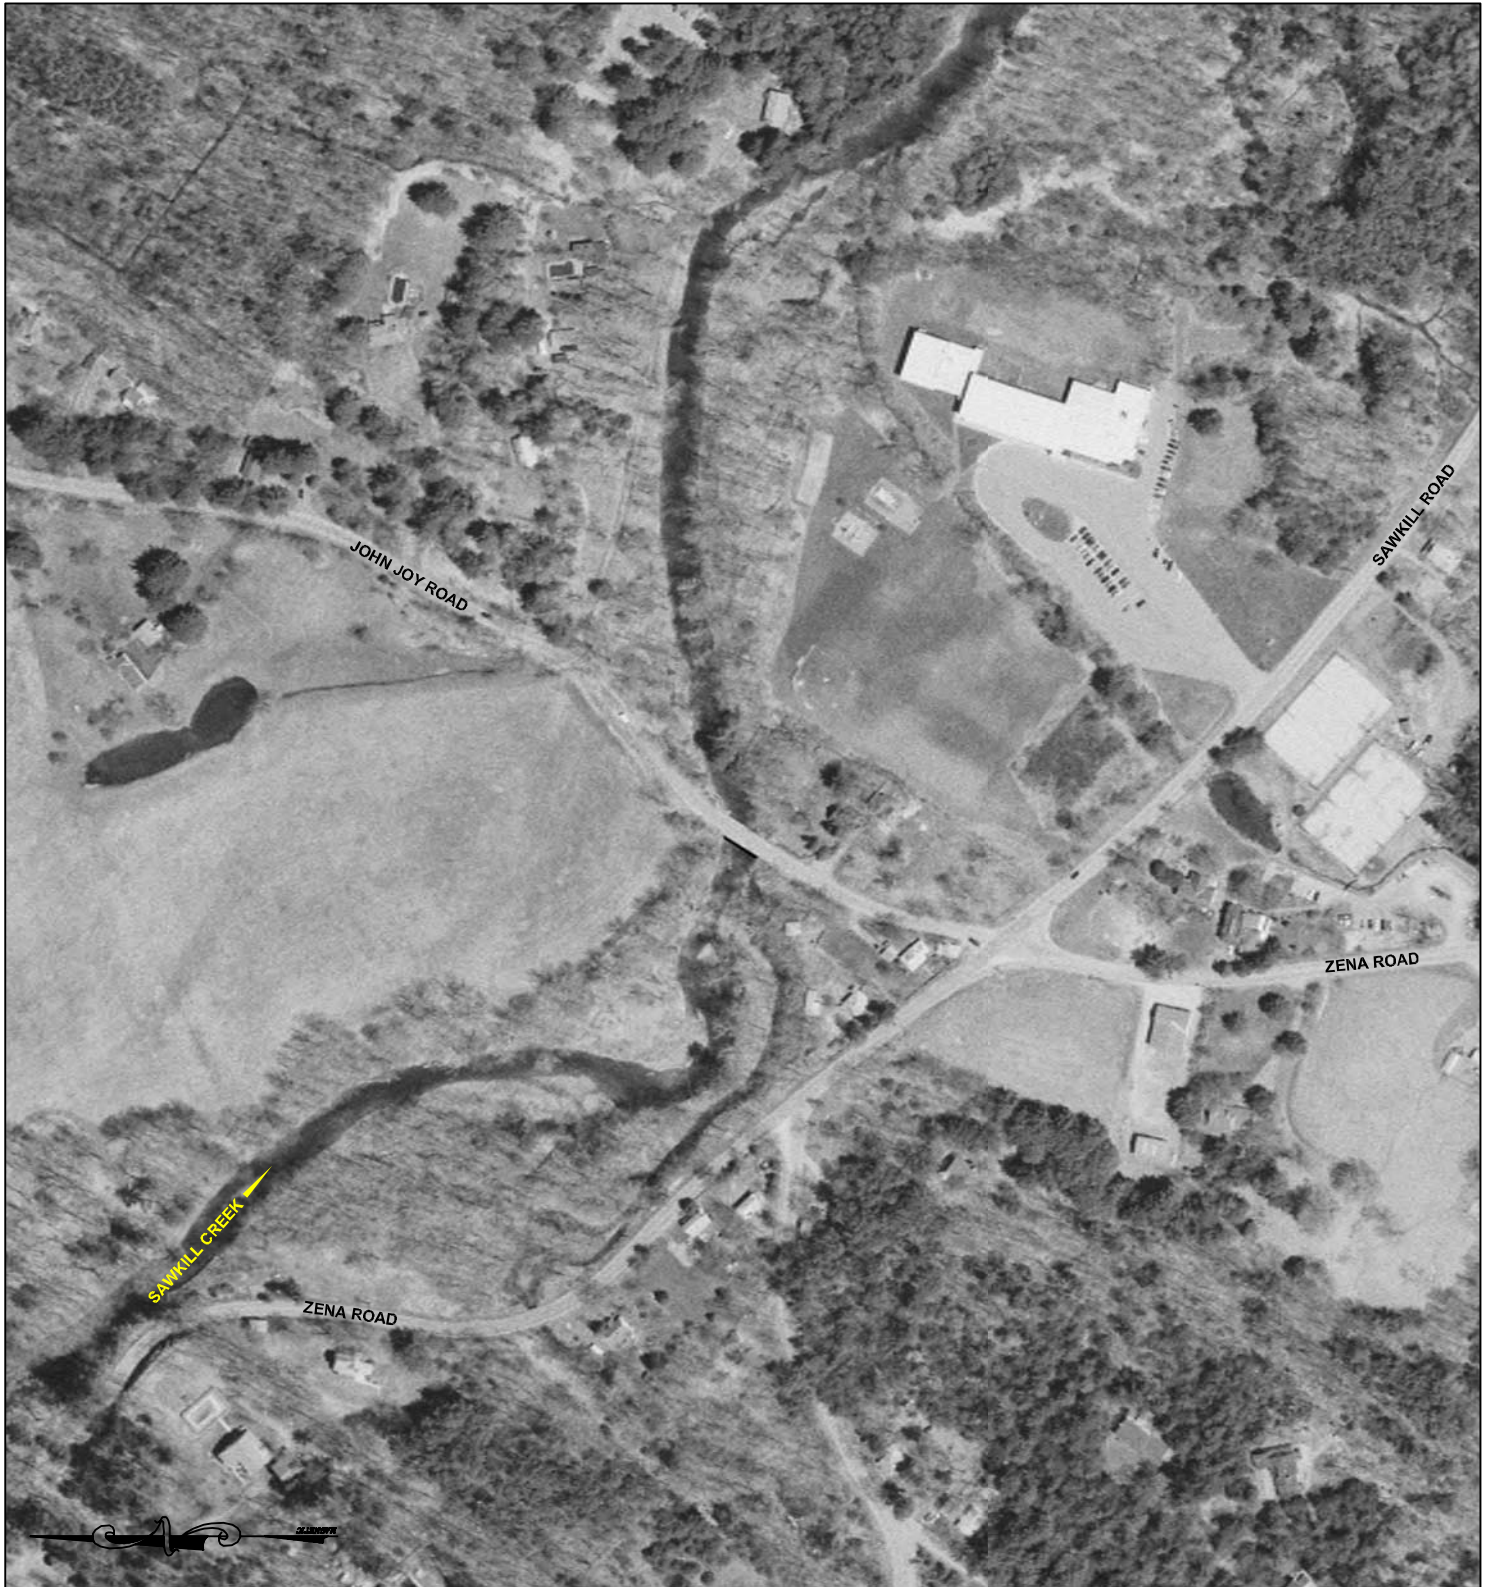
Figure 11: Sawkill Creek near John Joy Road.

The reaches surrounding the bridge are Rosgen “C4” type stream channels dominated by center and side bar gravel formations. These formations display little vegetation and evidence of recent enlargement. Channel sediments consisted of gravel substrate with several instances of recent deposition. The area upstream of the bridge on John Joy Road contained several debris jams and numerous downed trees, which most likely instigate sedimentation and aggravate flooding. Several recent deposits of sand, gravel, and debris were observed throughout the wooded portions of the floodplain.

Extensive streambank erosion along several meander bends located upstream of the bridge were noted. Review of aerial imagery from 1995, 2001 and 2004 revealed moderate lateral migration upstream of the bridge. Lateral migration measured 30 and 40 feet demonstrating rates of erosion of 4.5 to 5 feet per year. Further streambank erosion threatens the stability of the confluence with the “Van Dale Road” tributary.

Several past attempts to stabilize sections of the streambank using riprap and large rock were noted upstream of the bridge. Currently, numerous pieces of riprap have become dislodged and are scattered along the channel bottom. The stream has flanked a section of the failed riprap that now extends into a portion of the active channel, creating a minor flow diversion.

The recurring problems with debris and sediment accumulation, bank scour, and erosion upstream of the John Joy Road Bridge should be further investigated to determine their causes. From this initial evaluation it is suspected that the following factors compound these problems:

- The inadequate cumulative hydraulic capacity of the bridge structure and floodplain may result in backwater (and a subsequent accumulation of gravel and debris) during high flow events.
- The sediment accumulation causes a reduction in mean stream-channel depth, upstream from the bridge area, which results in both lower flow velocity and reduced sediment transport capacity.
- Erosion both in the reach and from upstream areas contributes to an excessive, supply of sediment and large woody debris.
- The natural tendency of the stream channel to migrate both laterally and down valley will intensify both sediment and debris supply to the site.

Development of a hydraulic model of the bridge and surrounding reach is recommended. Standard models (e.g. HEC RAS) can provide the ability to analyze hydraulic requirements necessary to reduce floodwater surface elevations and improve water and sediment conveyance through bridge and floodplain. The developed model could be used to efficiently evaluate multiple scenarios and would be required to analytically justify any alternatives.

The potential alternative exists to raise the elevation of John Joy Road on the northern portion of the bridge approach in attempt to alleviate flooding of the roadway and to lessen damage during moderate flood events. Drainage under the road could be designed to allow passage of floodwater under the roadway onto the downstream floodplain area. Initial observations of the current profile of John Joy Road, the elevation of the bridge approach, and the elevations of the upstream and downstream floodplain appear to make this a feasible option. An adequately engineered design, one which takes into account the hydrology of the Sawkill Creek at this point and the hydraulics of both the bridge and surrounding floodplain area, would be required to determine the targeted flood flow and elevations used for the design in order to assure adequate protection of the roadway and upstream and downstream floodplain areas.

It is recommended that any direct attempt to alleviate flooding at the bridge should include stream restoration upstream of the bridge. This reach is an ideal candidate for “natural channel design” techniques to improve sediment transport, reduce local streambank erosion and sediment yield, and strengthen the confluence with “Van Dale Road” tributary, maintaining and possibly improving the habitat and natural characteristics of the stream channel.

If the problems causing the debris and sediment accumulation can not be addressed due to funding or time constraints, this area should receive limited routine maintenance to prevent future blockage of the bridge opening. If this is required, a management strategy should be developed for the area allowing controlled access by equipment to maintain proper stream channel alignment, dimensions, and slope that would not create additional impacts to the area nor neighboring stream reaches.

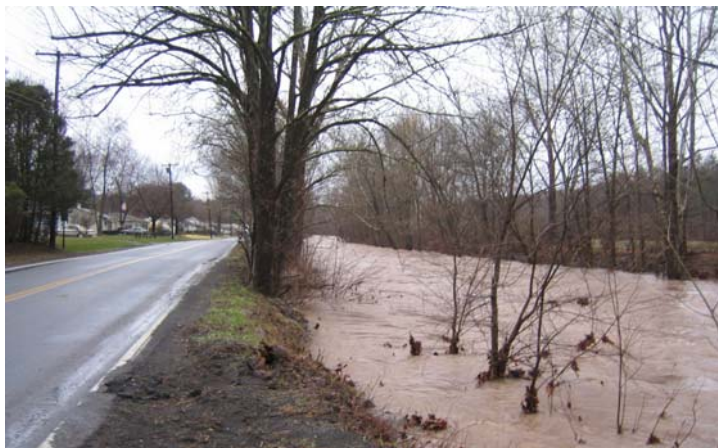
The Highway Superintendent and residents informed the group that the Sweet Meadows development and Sawkill Road (CR 31) have been flooded on numerous occasions. This has raised concern amongst numerous adjacent landowners not only within the Sweet Meadows development, but also in the Town. It was stated that on several occasions Sawkill Road has been closed due to the flooding, which creates a safety issue where emergency vehicles and residents must take an extensive detour around the flooded site.

Several homeowners have endured property damage and flooding of their residences in the past and report that the frequency and magnitude of the flooding has increased and will result in more severe damage. Floodwater in the Sawkill Creek has been observed by the residents to recede quickly after a flood event and has been known to leave fish lying along the roadway.

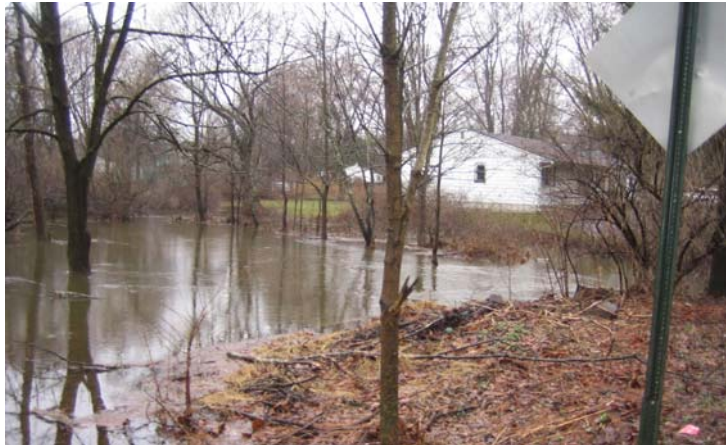
An unnamed tributary enters the Sawkill Creek immediately downstream of the Sweet Meadows area. The tributary flows from the western slopes of Jockey Hill along Moray Hill Road and then behind (south of) Sweet Meadows before flowing under Sawkill Road and entering the Sawkill Creek. On several occasions the tributary has also flooded portions of the Sweet Meadows site.

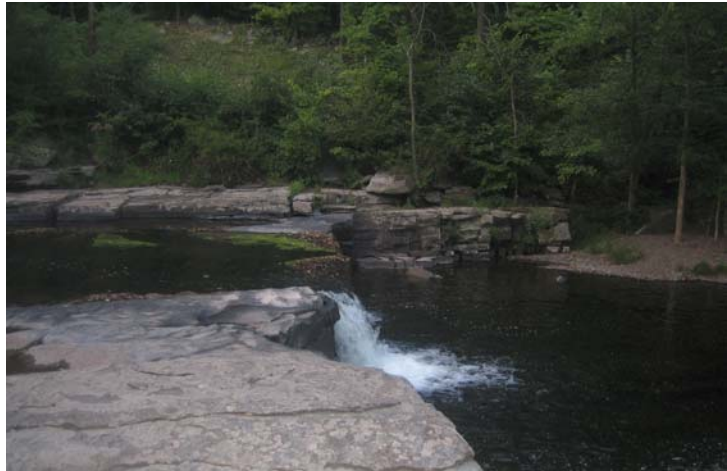
A large bedrock shelf acts as a waterfall at the lower extents of the reach providing both lateral stability and grade control for the area. A small unnamed tributary flows behind the residences of Sweet Meadows. Erosion was present within this channel and evidence of channel incision of between one and three feet was observed.

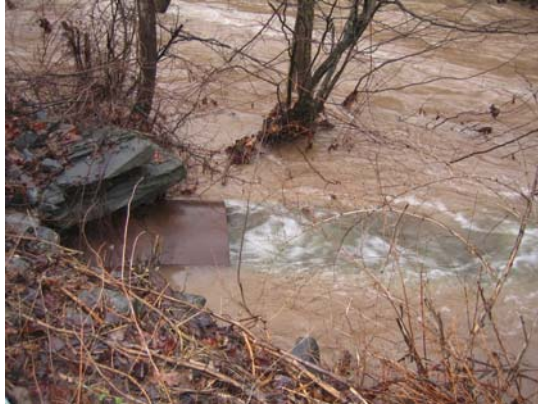
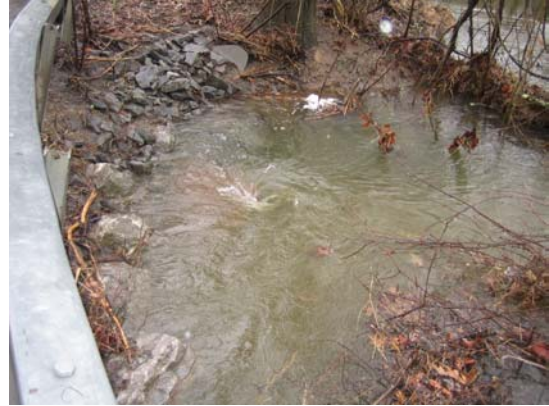
The stormwater drainage network in the Sweet Meadows development and along Sawkill Road may exacerbate flooding in instances where runoff within the area cannot drain properly. Although not assessed as part of this study, it is possible that the discharge pipes of the drainage network are submerged during periods of elevated flow in both the Sawkill Creek and the tributary. This situation could lead to the reduction in the volume of stormwater exiting the site during periods of elevated water surface elevations in the Sawkill Creek and tributary.

A review of the existing stormwater drainage network within the Sweet Meadows development should be conducted. The review and/or assessment should determine: the locations and sizes of catch basins and subsurface piping, the locations of the stormwater outfalls to both the Sawkill Creek and the tributary and their respective elevations relative to each stream channel, and estimated water surface elevation during flood stage. In addition, the capacity of the system should be determined in relation to outfall of the system during various flood stages.

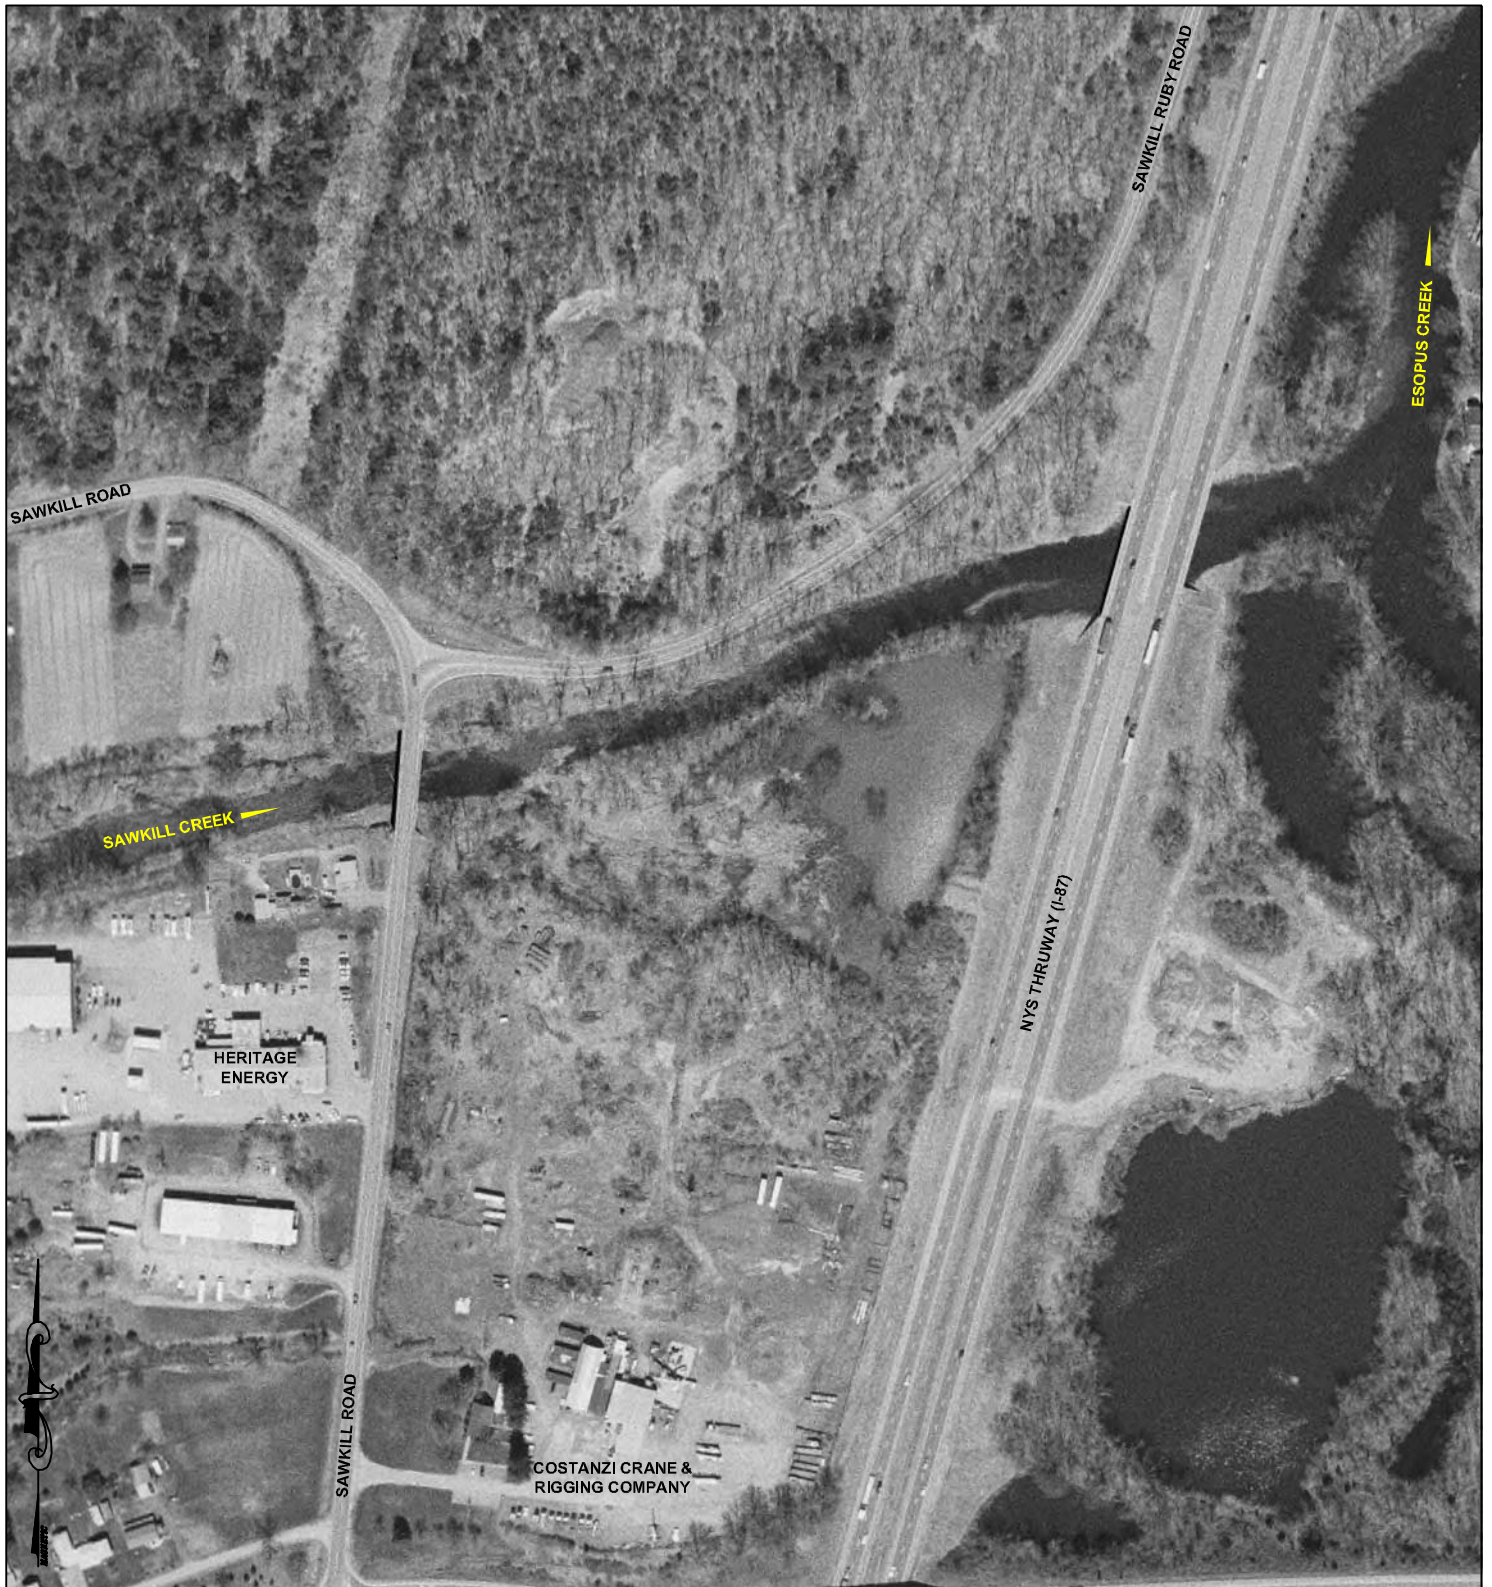
Figure 13: Sawkill Creek near confluence with Esopus Creek.

The frequency and extent of flooding in this particular area generally depends on amount of precipitation, the timing of flood peaks between the Sawkill and Esopus Creeks, and local obstructions in the channel and floodplain in the area of the bridge structures. The most significant flooding in this area of the Sawkill Creek would generally occur when large floods in both systems peak simultaneously

Flooding of the Heritage Energy and Eagle Diesel Power parking lots were observed on April 16, 2007 following a heavy rain event. During this event the Sawkill Creek did not crest the top of the bank, or result in flooding of the area. Flood water from the small unnamed tributary which flows east along the property owned by Eagle Diesel Power, was observed overtopping its banks and inundating the area west of Sawkill Road. This condition may aggravate and increase flooding of the area during periods where inundation occurs as the result of the Sawkill Creek flooding.

Due to the scale and complexity of the Sawkill and Esopus watersheds, a thorough understating of the hydrology and hydraulics would be required to effectively alleviate existing and future flood risk. It is recommended that the Towns of these watersheds assess the need for the development of a hydrologic model to understand the existing conditions of the watersheds. Hydrologic modeling that can simulate precipitation runoff and routing would act as a decision support tool for future mitigation planning. Data used in the creation of hydrologic model, and model output can be used to identify and prioritize sub basins based on their response to precipitation. The model can be used to facilitate effective selection of alternatives for structural and nonstructural controls to provide floodwater elevation reduction, reduce existing damage, and prevent future damages.

It is recommended that the existing stormwater drainage network within this area be investigated, and opportunities for modifying the tributary and/or stormwater network be evaluated to more effectively transport flow to the Sawkill Creek and away from the parking areas.

Modification that would result in a decrease in flood storage capability of this area should be avoided. In addition, opportunities may exist to enhance this area for increased levels of floodwater storage, as well as improve habitat benefits.
